**Tank-Car Thermal Protection Defect Assessment:
Updated Thermal Modelling with
Results of Fire Testing**

SUMMARY REPORT

Transportation Development Centre
of
Transport Canada

A.M. Birk Engineering
Kingston, Ontario, Canada

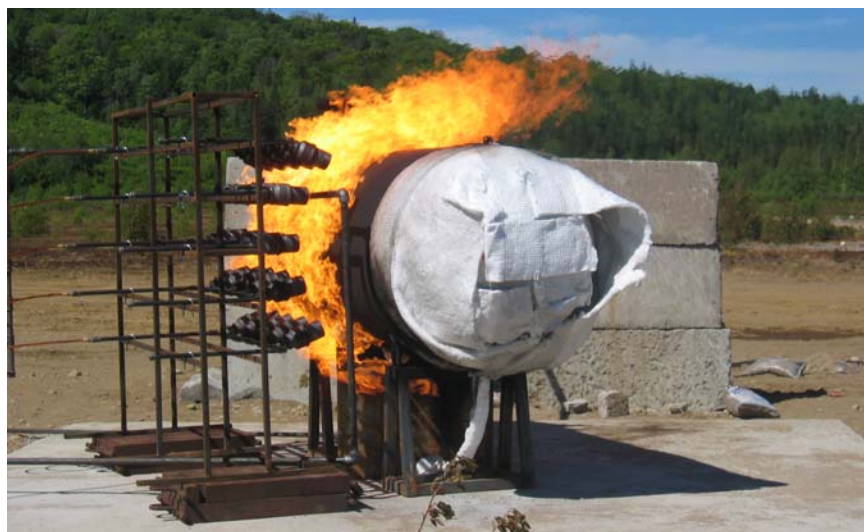
Figure 4: ASME Code 500 gal. Test Tank with 25% Fire Engulfment (fire blackbody temperature 800-900°C) [4]

These tanks were 25 percent engulfed in fire. The fire blackbody temperature was in the range of 800 to 900°C, which is in the range of credible hydrocarbon pool fires. Three cases are presented here – a baseline test with an unprotected tank (no insulation or jacket) and then 15 percent (large defect) and 8 percent defect cases. The tanks were protected with new tank-car insulation (13 mm ceramic blanket) and this was covered with a 3 mm steel jacket in the area covered by fire.

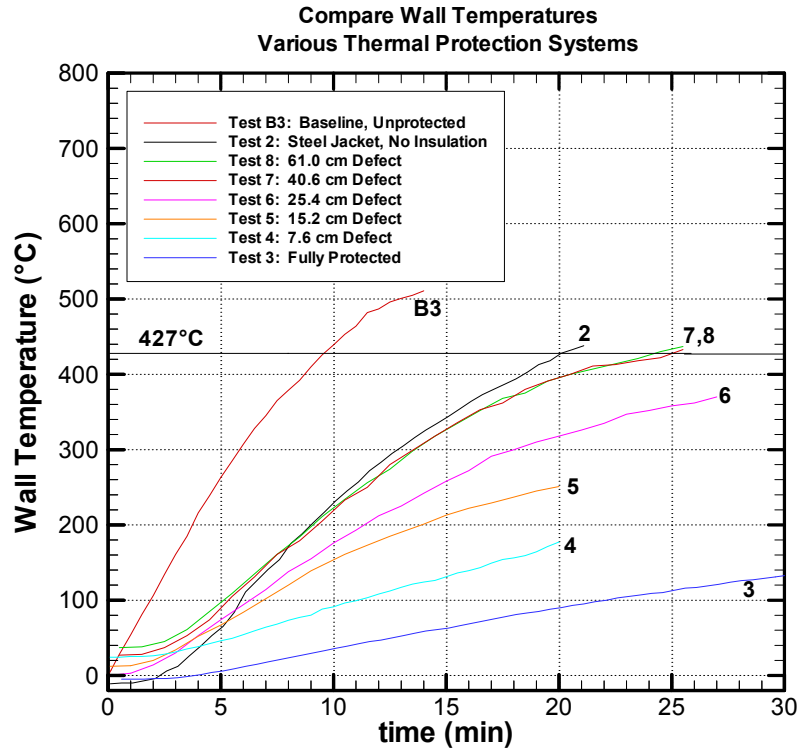
Figure 7: Measured Peak Temperatures Under Thermal Protection Defects (16 mm plate) Heated by Engulfing Fire (effective blackbody $T = 840^{\circ}\text{C}$) [16]

Heat transfer modelling [6] and fire testing [16] have shown that the critical defect size, from the standpoint of heat transfer, for a 16 mm thick plate is about 0.4 m x 0.4 m. At this size the centre of the defect area is not significantly cooled by the surrounding protected and cool metal. In other words, the centre of this plate will heat up as if it were not surrounded by protected material. This is shown in Figure 7 from [16].

As can be seen from Figure 7, a defect 0.4 m square (test 7) is about the same as a 100 percent defect case (test 2).

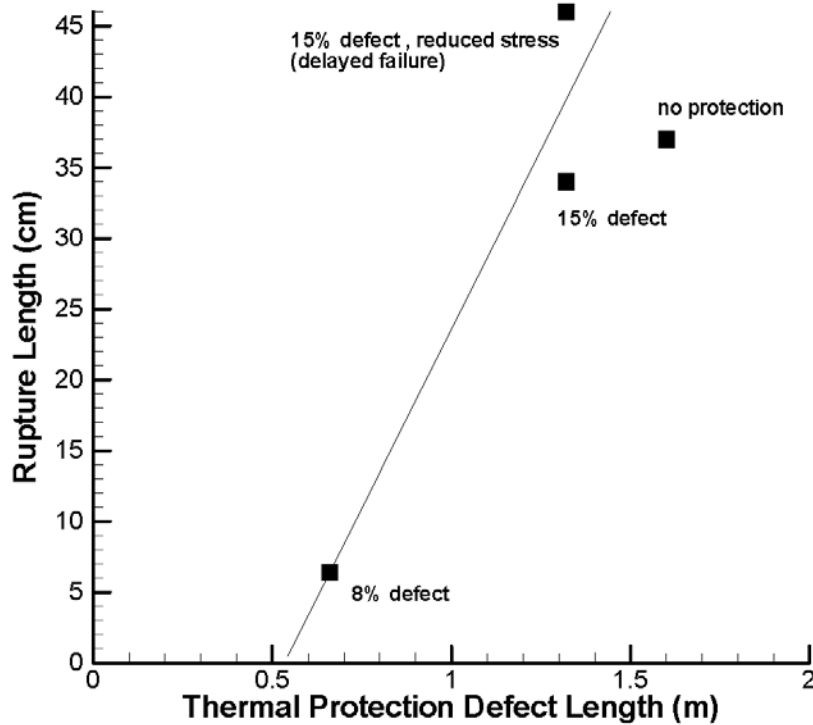
Figure 8: Rupture Length vs. Thermal Protection Defect Length (500 gal. tank, D = 0.96 m, 7.1 mm wall, SA 455 steel, fire heated length about 1.6 m, data from [4])

The length of the resulting ruptures depended on the length (along the tank axis) of the thermal protection defect. Figure 8 shows how the rupture length varied with the thermal protection defect length. If we linearly extrapolate this data to zero rupture length (pin hole) then the resulting thermal protection defect length is about 0.55 m for the 500 gal. tank. This was for a 7.1 mm thick wall. If we scale this size based on the plate thickness, then the defect must be about 1.2 m long for a 112J tank-car with a 16 mm thick wall.

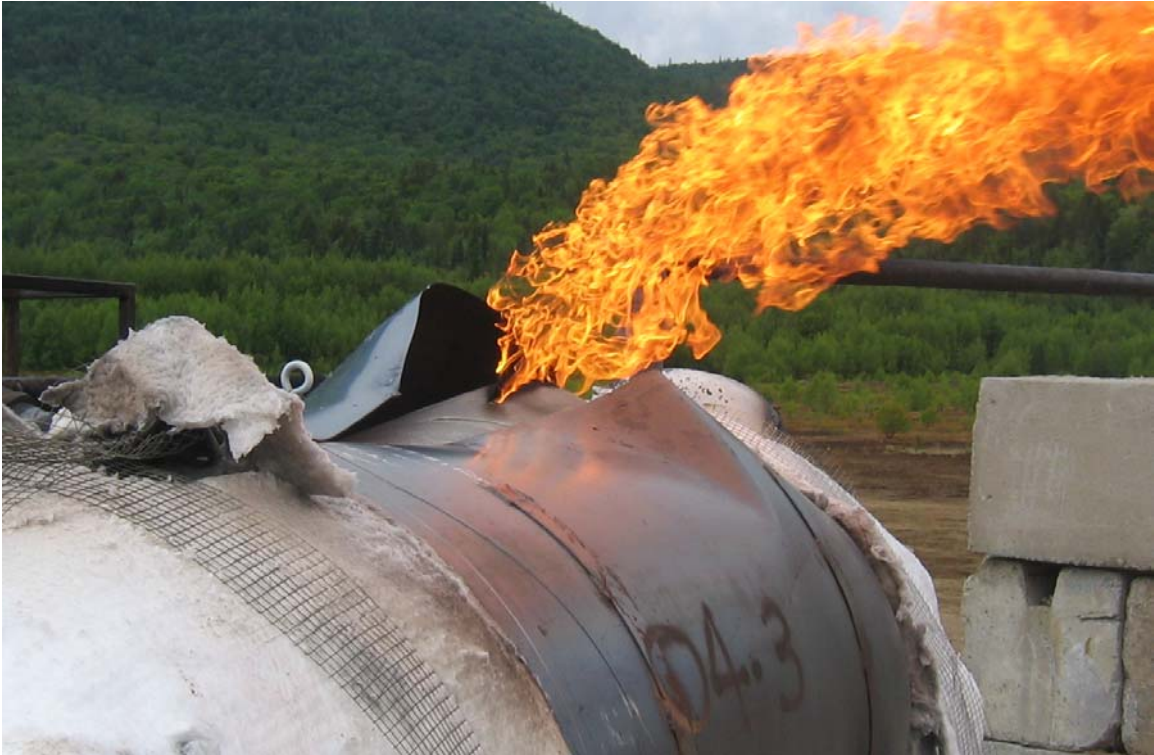
Figure 9: Ruptured Tank with 15 percent Thermal Protection Defect [4]

Figure 9 shows a picture of a ruptured 500 gal. tank with a thermal protection defect. This tank had a defect about 1.3 m along the tank axis. This thermal protection defect would scale to about 3 m in length on a 112J tank-car. The failure length would scale to about 0.8 m on a tank-car.

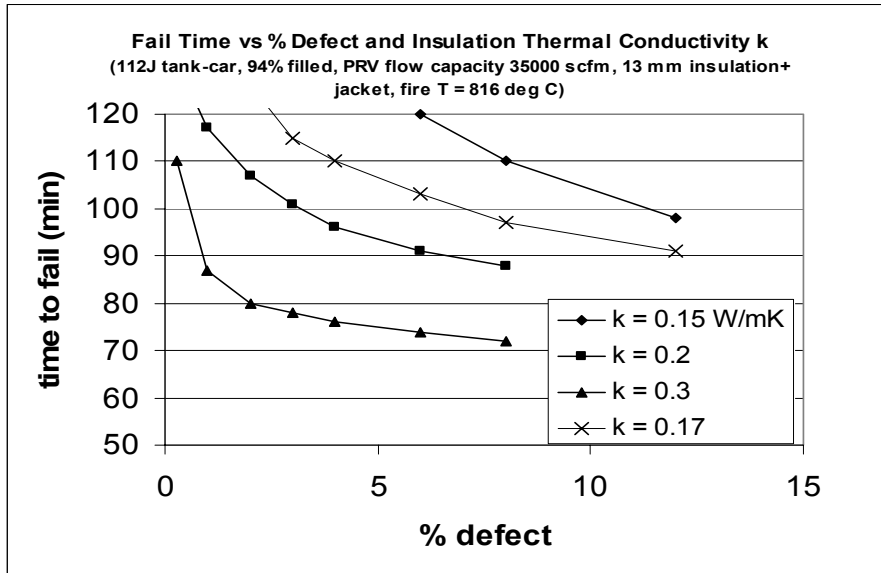
Figure 10: Predicted Time to Failure vs. % Defect and Overall Effective Thermal Conductivity of Thermal Protection System (assumes 13 mm ceramic blanket)

A set of simulations was performed for a range of defect areas and k values. These are summarized in Figure 10. As can be seen from the figure, the allowable defect depends strongly on the effective conductance of the overall thermal protection system. We do not have any good data for this from the existing tank-car fleet. Testing is necessary to establish this.
